Manhole Inspection Summary

Manhole # S25CC2002MH

Location Address: **802 SAINT GEORGES RD**

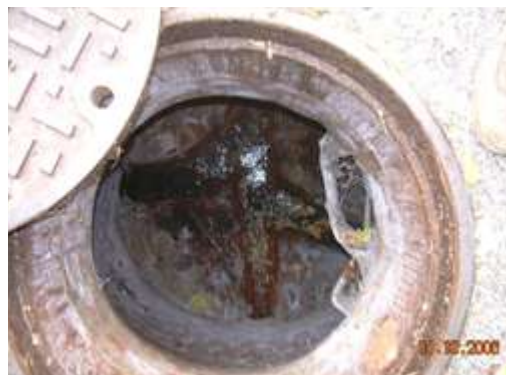
Top View

Bench and Channel debris.

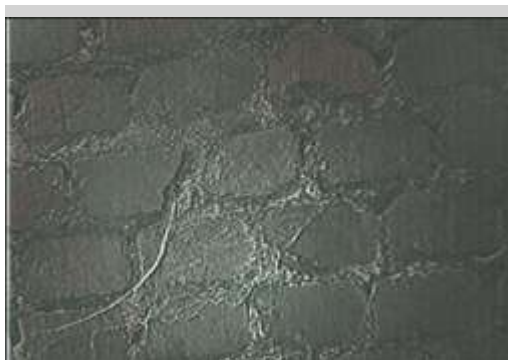
Defect

Barrel deterioration, root intrusion and infiltration.

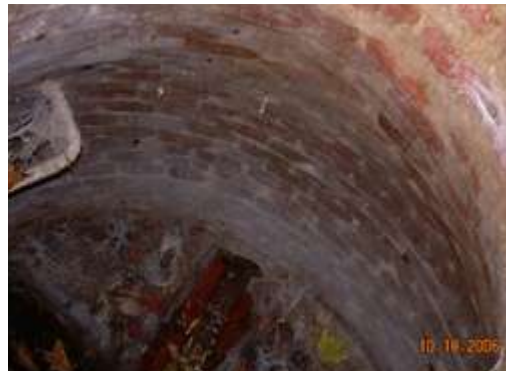
Defect

Adjustment, Corbel and Barrel infiltration.

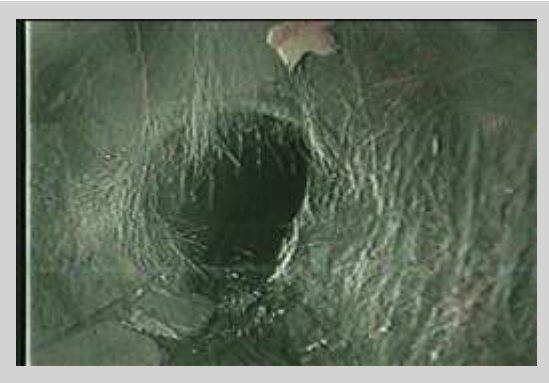
8 in. Circular Gravity Sewer Pipe Out @ 12 O'Clock

Barrel, Bench and Channel root intrusion.

Infiltration: **Evidence** Pipe Seal Cond: **Roots**

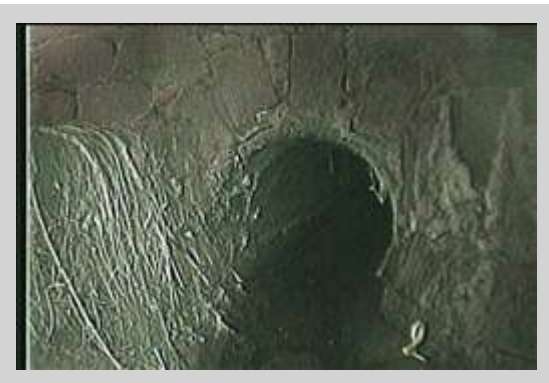
6 in. Circular Gravity Sewer Pipe In @ 4 O'Clock

Bench root intrusion.

Infiltration: **Evidence** Pipe Seal Cond: **Roots**

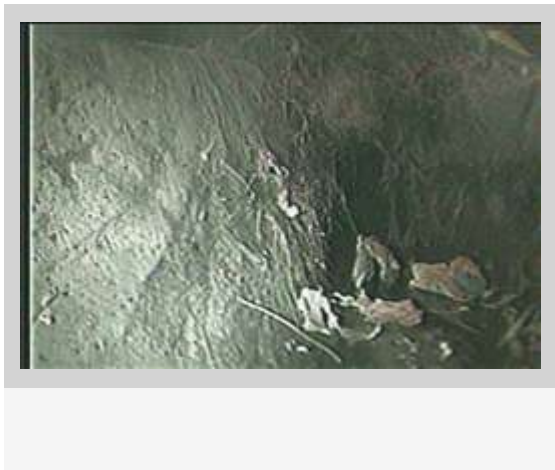
6 in. Circular Gravity Sewer
Pipe In @ 6 O'Clock

Infiltration: **Evidence** Pipe Seal Cond: **Roots**

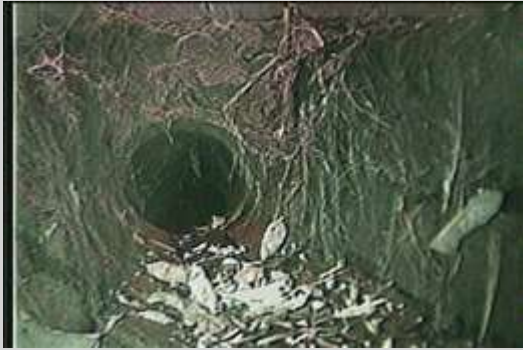
Pipe In @ 9 O'Clock

Barrel deterioration, root intrusion and infiltration. Channel deterioration and root intrusion.

Infiltration: **Evidence** Pipe Seal Cond: **Roots**
